Printed: February 1984 Tested at: Lethbridge ISSN 0383-3445 Group 3c

# **EVALUATION REPORT** 348

# VALLEY UNIVERSAL RAINGER MODEL 9880 LINEAR MOVE IRRIGATION SYSTEM

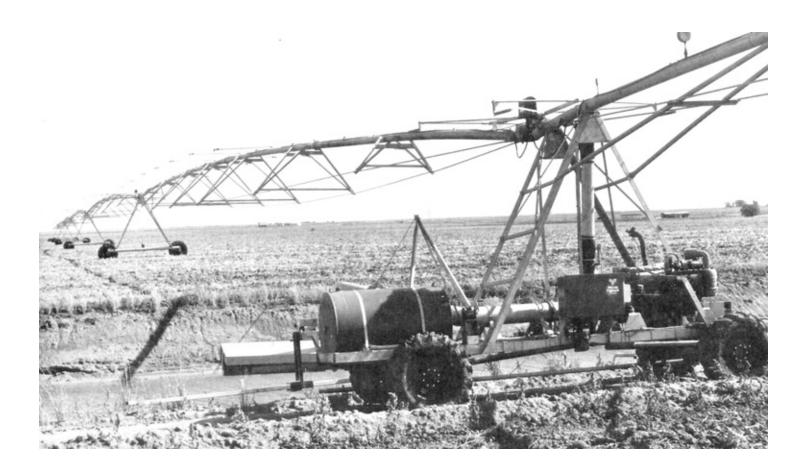
FIGURE 1. Valley Universal Rainger Model 9880 Linear Move Irrigation System: (1) Lateral Pipe, (2) Nozzles, (3) Truss Supports, (4) Support Tower, (5) Steering Arms, (6) Guide Posts, (7) Fuel Tank, (8) Control Panel, (9) Pump, (10) Diesel Engine, (11) Generator.

FIGURE 1 shows the location of major components while detailed specifications are given in APPENDIX I.

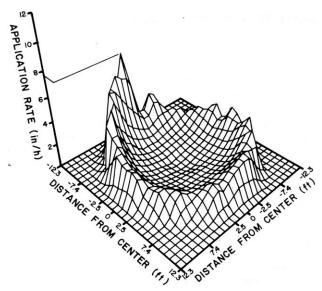
FIGURE 3. Distribution Pattern of a Delavan RA-95 Raindrop Spray Nozzle at a 167 in (4250 mm) Discharge Height and a Pressure of 20 psi (140 kPa).

Nozzle Distribution Patterns: Delavan Raindrop nozzles (FIGURE 2) delivered spray downward in a hollow conical fashion resulting in a circular ring-shaped distribution pattern. FIGURE 3 shows a typical distribution pattern of a single stationary RA-95 Raindrop nozzle when operating at 20 psi (140 kPa) and a 167 in (4250 mm) discharge height. Higher applications occurred at the perimeter of the pattern than the interior. Very high applications occurred in one region of the perimeter. This region was characteristic of all nozzles tested and occurred in a similar relative position. TABLE 2 shows the average<sup>2</sup> and maximum application rates of various sizes of Delavan Raindrop nozzles while operating at a 167 in (4250 mm) discharge height and 20 psi (140 kPa). High application rates can cause local ponding and run-off on certain soils. Care has to be exercised during system design to ensure application rates do not exceed soil infiltration capacity.

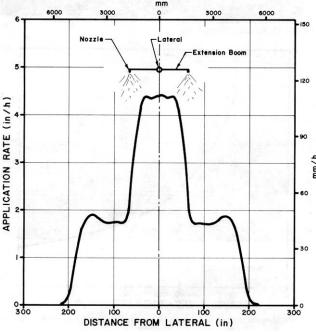
FIGURE 8. Theoretical Average Application Rates for Various Positions About the Lateral.

**Extension Booms:** Nozzle extension booms increased the area over which water was applied. FIGURE 8 shows the theoretical average application rates of the test machine for various positions about the lateral when equipped with 60 in (1525 mm) extension booms. High applications occur below the lateral and up to 150 in (3810 mm) on either side of the lateral

The average theoretical application rate for the test machine was 2.2 in/h (56 mm/h). Maximum application rate for the test machine was 13.7 in/h (348 mm/h). High application rates can cause local ponding and runoff on certain soils. Few soils can accept such high instantaneous applications for more than a few minutes. For the test machine, local ponding occurred at various positions along the lateral when operated at slow speeds. As already recommended, modifications to eliminate high applications are required.

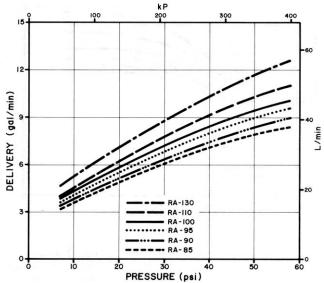
FIGURE 9. Delivery Rates for Various Sizes of Delavan Raindrop Spray Nozzles over a Range of Pressures.

**Nozzle Calibration:** FIGURE 9 shows the average delivery of various sizes of Delavan Raindrop nozzles over a range of operating pressures. Delivery rate increased less than 1.0% about 820 hours of field use. Nozzle wear would depend on water cleanliness and type, if any, of chemicals used.

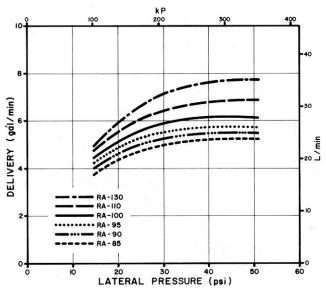
FIGURE 11. Delivery Rates for Various Sizes of Delavan Raindrop Spray Nozzles Equipped with 20 psi (140 kPa) Senninger Pressure Regulators.

The 20 psi (140 kPa) Senninger pressure regulators (FIGURE 10) were effective in reducing nozzle delivery variations resulting from lateral pressure variations. FIGURE 11 shows the average delivery of various Delavan nozzles when equipped with the Senninger pressure regulators. The use of pressure regulators is recommended where lateral pressures are subject to large variations. For example, nozzle delivery from an RA-100 nozzle equipped with a regulator operating at a lateral pressure of 35 psi (240 kPa) decreased only 7 per cent for a 30 per cent decrease in lateral pressure.

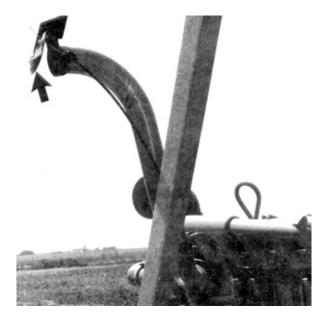
The pump was primed by activating an engine exhaust valve (FIGURE 13) to supply vacuum to the intake pipe. Priming was difficult as a proper seal at the exhaust valve could not be achieved. It is recommended that the manufacturer modify the valve to provide adequate intake pipe vacuum.

FIGURE 13. Exhaust Priming Valve.

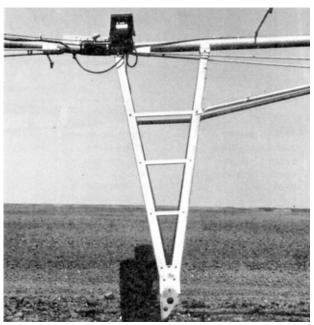
**Towers:** The support towers (FIGURE 18) provided convenient access to the tower electrical control boxes. The electrical control boxes were suitably protected from precipitation. Adjustment of the tower alignment linkages was easy but required tools.

FIGURE 18. Valley Universal Rainger Support Tower.

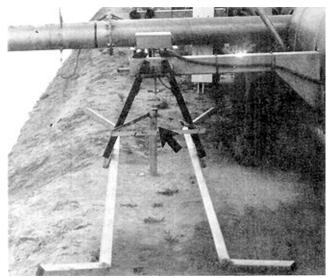
Safety Devices: The Valley Universal Rainger was equipped with automatic safety devices to provide system shut-off in the event of mechanical or electrical failures. Safety switches on the engine control panel monitored engine oil level, engine temperature, engine vacuum, engine oil pressure and system water pressure. The control panel included safety devices to monitor system electrical power levels. Safety switches located on the steering arms prevented over-watering and excessive path variations while safety switches located at each support tower prevented excessive tower alignment deviation. The Valley Universal Rainger automatically shut off when the end of the field was reached. The standard steering arm "end of field shut-off" (FIGURE 20) ensured system shut-off at the field ends.

FIGURE 20. Steering Arm End of Field Shut-off.
